MOORING CONDITION REPORT

**NORFOLK NAVAL
SHIPYARD**

CR-6119-OCN

September, 1999

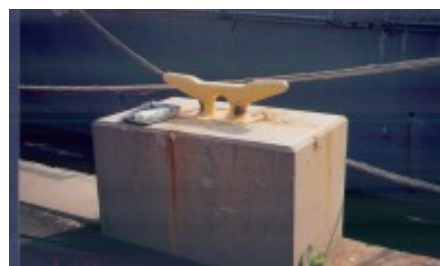
Photo 3.1-1, Berth 1, fitting B1-B1, Sta. 0+15.8, 50 ton bollard in good condition, #2 rating.

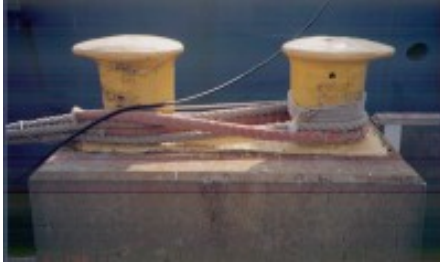
Photo 3.1-2, Berth 1, fitting B1-C2, Sta. 0+70, 42-inch type 3 cleat in good condition, #2 rating

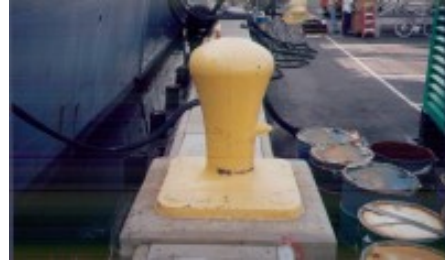
Photo 3.1-3, Berth 1, fitting B1-BT1, Sta. 0+96, low double bitt in good condition, # 2 rating.

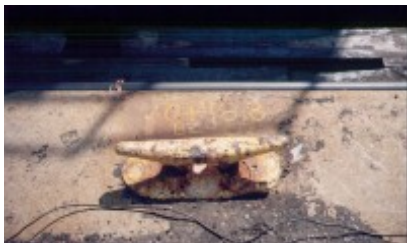
Photo 3.2-1 Berth 2, fitting B2-C2, Sta. 0+48.8, 26-inch cleat exhibits scaling of coated surface, #3 rating

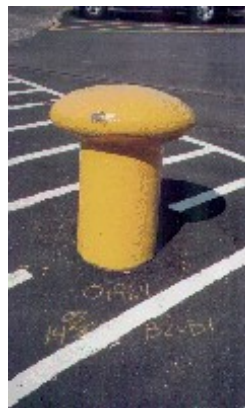
Photo 3.2-2 Berth 2, fitting B2-B1, Sta. 0+91.4 single bitt base is paved over, fitting in good condition, #1 rating

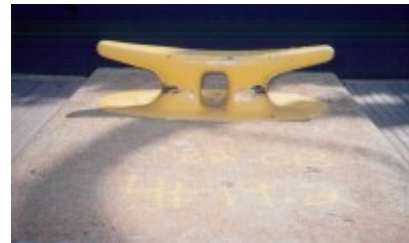
Photo 3.2-3 Berth 2, fitting B2-C13, Sta. 4+19.2 26-inch cleat in good condition, #1 rating

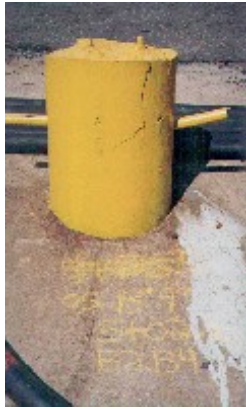
Photo 3.2-4 Berth 2 fitting B2-B4, Sta. 5+02.6, single bitt top has been sheared off, #4 rating

Fitting B2-B4 should be taken out of service and not used until it can be replaced in-kind. There are no other conditions which warrant downgrading of any fixture's capacity at this time. Examples of typical fixtures are shown on the photo page of this section. The data tables included in this section present detailed information on each fitting. The fender system at Berth 2 is in good operational condition.

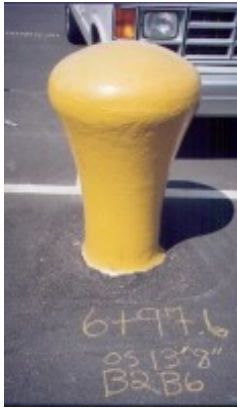
Photo 3.2-5 Berth 2, fitting B2-B6, Sta. 6+97.6, 50 ton bollard, base is paved over, fitting in good condition, #1 rating

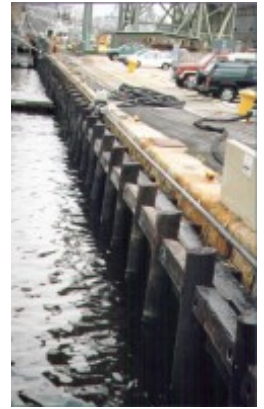
Photo 3.2-6 Berth 2, Fender system overview

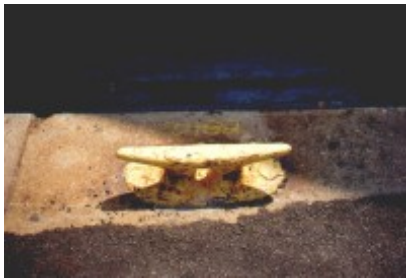
Photo 3.2-7 Berth 2, fitting B2-C3, Sta. 0+82, 26" cleat exhibits severe scaling and corrosion, #3 rating

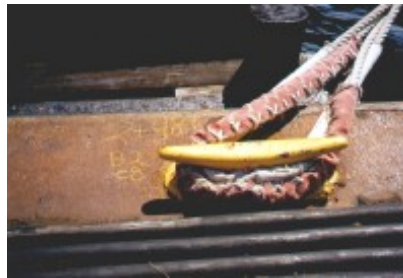
Photo 3.2-8 Berth 2, fitting B2-C8, Sta. 2+48.6, 26" cleat base exhibits cracking, #3 rating

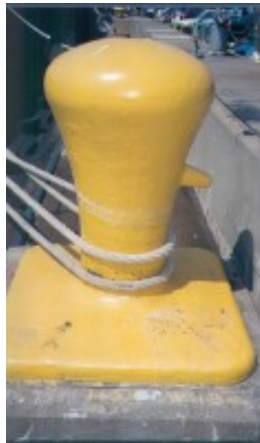
Photo 3.3-1 Berth 3, fitting WS1-B2, Sta. 1+24, 50 ton bollard in good condition, #1 rating

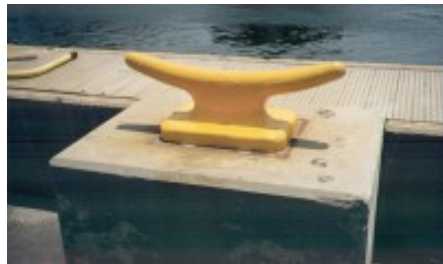
Photo 3.3-3 Berth 4, fitting WS1-11, Sta. 7+29.8 42-inch type 2 cleat, #1 rating

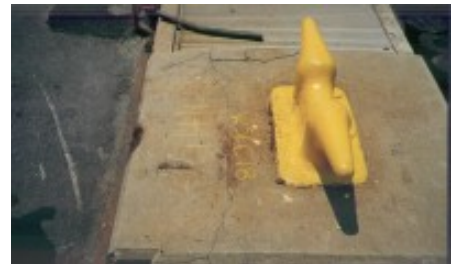
Photo 3.3-4 Berth 5, fitting WS1-C18, Sta. 10+81.5, 42-inch type 1 cleat, #2 rating due to cracking of the concrete base

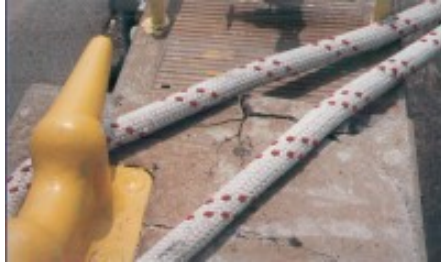
Photo 3.3-7 Berth 6, fitting WS1-C29, Sta. 17+14, close up view of cracked concrete base in front of cleat

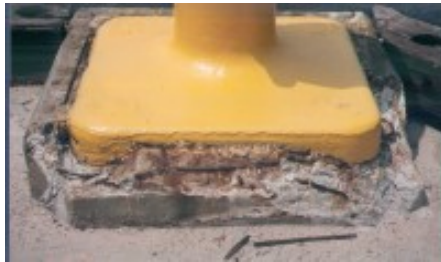
Photo 3.3-9 Berth 6, fitting WS1-B8, Sta. 17+78.5, close up of deteriorated concrete base

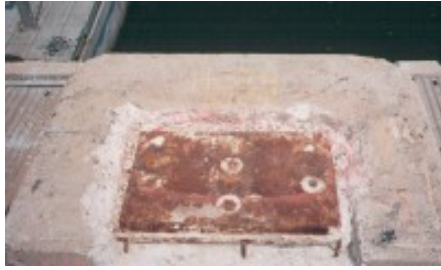
Photo3.4-1 Berth 7, fitting B7-C4, Sta. 1+37.4, 26-inch cleat bolts are cut off and cleat is missing, #4 rating

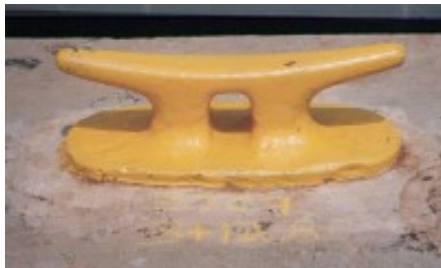
Photo 3.4-3 Berth 7 fitting B7-C9, Sta. 3+12.8, 26-inch cleat in good condition, #2 rating

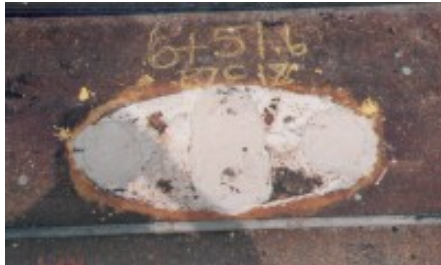
Photo 3.4-5 Berth 8, fitting B7-C18, Sta. 6+51.6, 26" cleat bolts are sheared off and cleat is missing, #4 rating

At Berth No. 8 two cleats, B7-C17 and B7-C18, have received a 4 rating as these cleats are missing. These cleats should not be considered in any berthing plan until replacement has been completed. All other fittings on Berth 8 and Berth 7 have 1 or 2 ratings and are considered to be in good condition. The fender system at Berths 7 and 8 is in good operational condition.

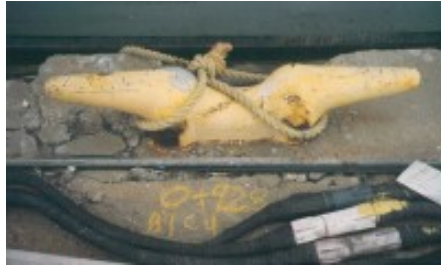
Photo 3.5-1 Berth 9, fitting B9-C4, Sta. 0+92.8, 42" type 1 cleat in good condition with concrete base exhibiting cracking, #3 rating

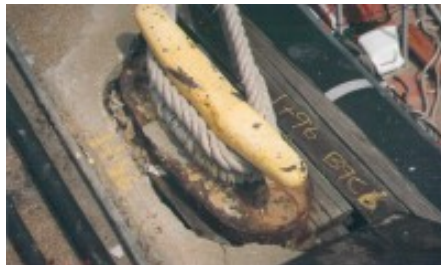
Photo 3.5-3 Berth 9 fitting B9-C6, Sta. 1+96, 26" cleat on timber base exhibiting rot resulting in a #4 rating

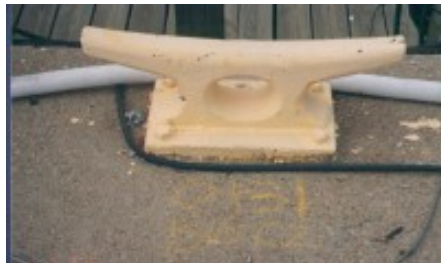
Photo 3.5-5 Berth 10, fitting B10-C2, Sta. 0+31, 29" cleat in good condition, #1 rating

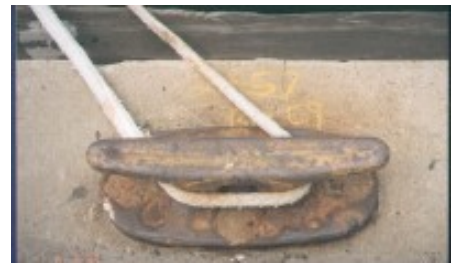
Photo 3.5-6 Berth 10, fitting B10-C9, Sta. 2+57, 26" cleat in good condition, #2 rating

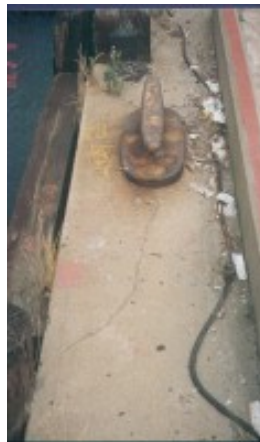
Photo 3.5-7 Berth 10, fitting B10-C10 Sta. 2+89, 26" cleat in good condition, cracking noted on concrete deck resulting in a #3 rating

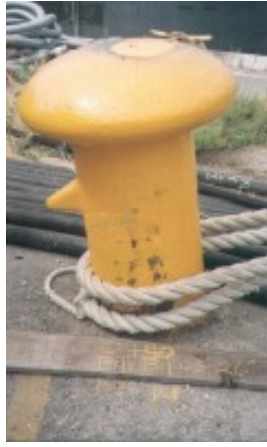
Photo 3.6-1 Berth 11, fitting B11-B1, Sta. 0+50, single bitt in good condition, #1 rating

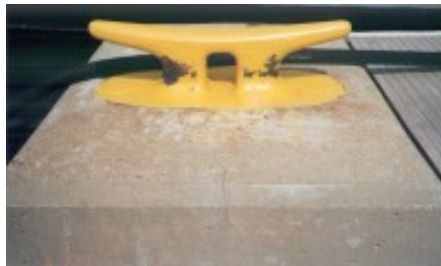
Photo 3.6-3 Berth 11, fitting B11-C3, Sta. 0+89.5, 26" cleat in good condition, #1 rating

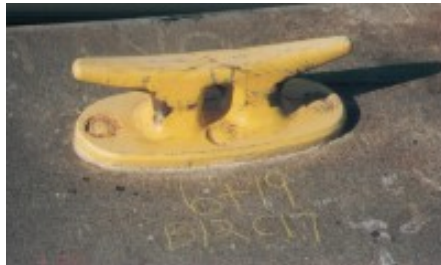
Photo 3.6-5 Berth 12, fitting B11-C17, Sta. 6+19 26" cleat in good condition, #1 rating

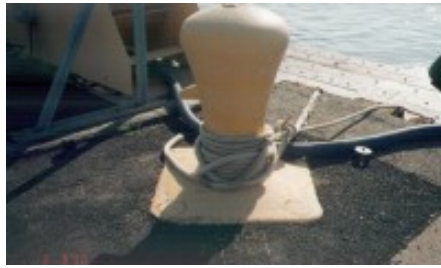
Photo 3.7-1 Berth 13, fitting B13-B1, Sta. 0+29 Bollard in good condition, #1 rating

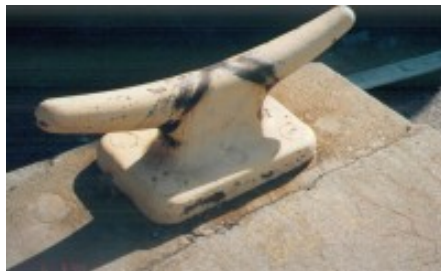
Photo 3.7-3 Berth 13, fitting B13-C2, Sta. 0+95 42" type 2 cleat in good condition, #1 rating

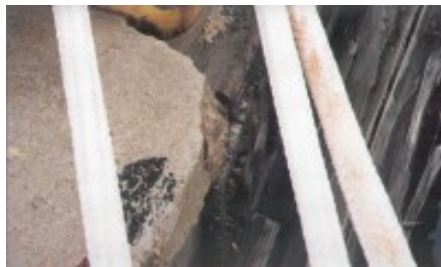
Photo 3.7-5 Berth 14, fitting B14-C3, Sta. 1+32.5 42" type 2 cleat, close-up view of timber at base

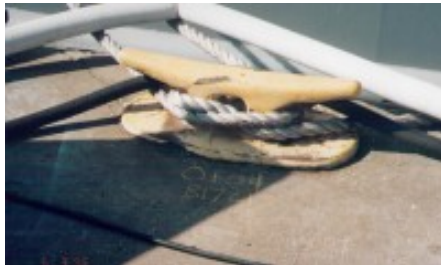
Photo 3.7-9 Berth 17, fitting B17-C1, Sta. 0+04 26" cleat in good condition, #2 rating

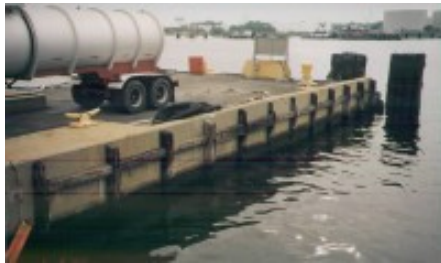
Photo 3.7-11 Berth 13, fender system with minor deterioration looking east

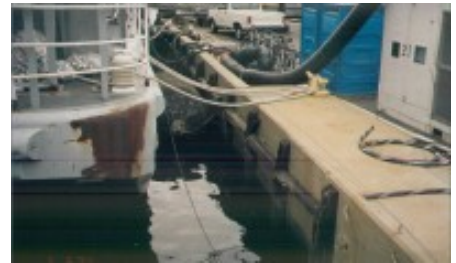
Photo 3.7-12 Berth 14, fender system with moderate deterioration looking south

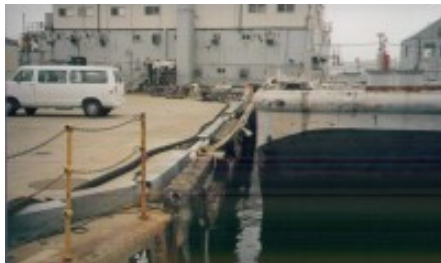
Photo 3.7-13 Berth 15, fender system with moderate deterioration looking east

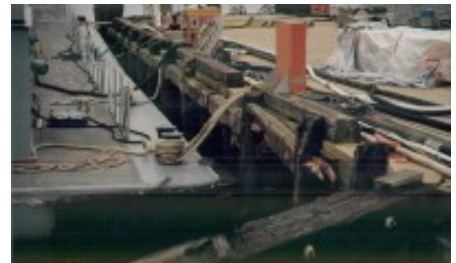
Photo 3.7-14 Berth 16, fender system with minor deterioration looking southeast

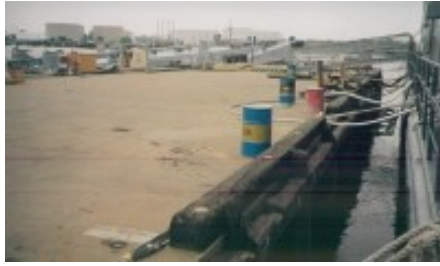
Photo 3.7-15 Berth 17, fender system with minor deterioration looking east

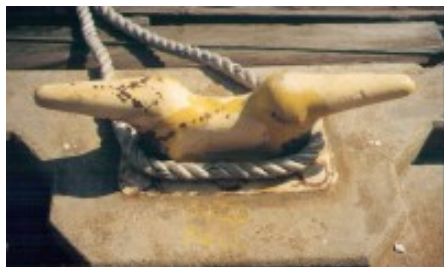
Photo 3.8-1 Berth 18, fitting B18-1, Sta. 0+20 42" type 1 cleat in good condition, #1 rating

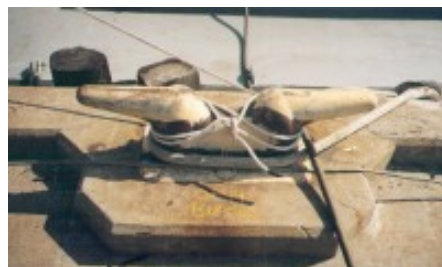
Photo 3.8-2 Berth 18, fitting B18-C2, Sta. 0+44 42" type 1 cleat in good condition, #2 rating

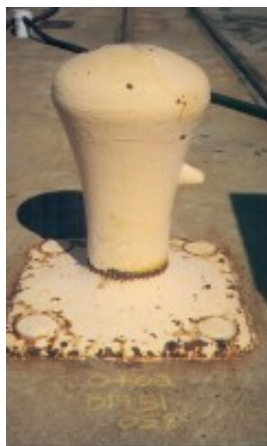
Photo 3.8-3 Berth 19, fitting B19-B1, Sta. 0+02, bollard in good condition, #2 rating

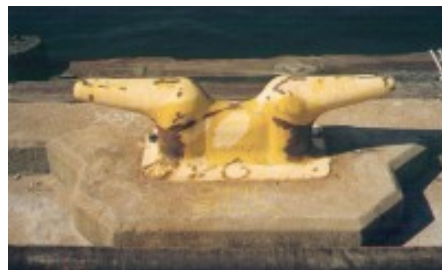
Photo 3.8-4 Berth 19, fitting B19-C2, Sta. 0+41 42" type 1 cleat in good condition, #2 rating

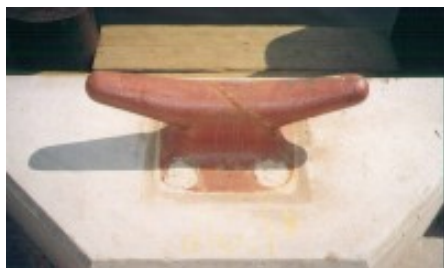
Photo 3.8-5 Berth 20, fitting B20-C1, Sta. 0+18 30" cleat in good condition, #1 rating

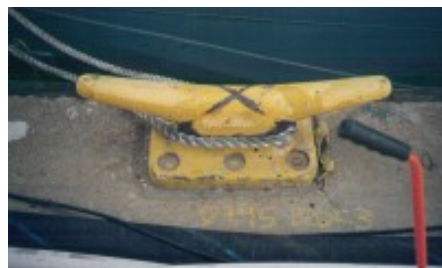
Photo 3.8-6 Berth 20, fitting B20-C3, Sta. 0+95 42" type 2 cleat, concrete base exhibits cracking resulting in a #2 rating

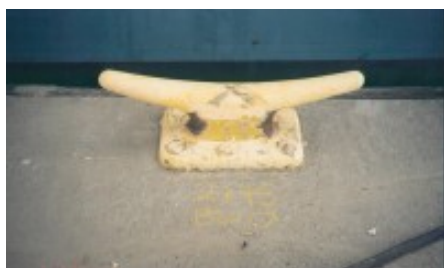
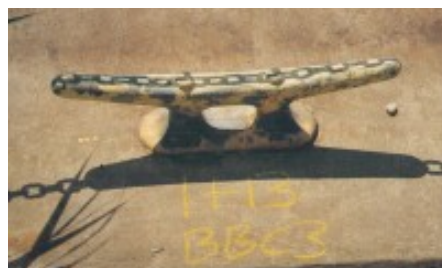
Photo 3.8-7 Berth 20, fitting B20-C7, Sta. 2+45 42" type 2 cleat in good condition, #1 rating

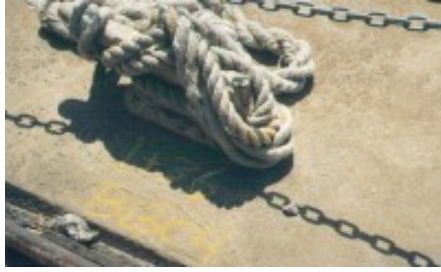
Photo 3.8-8 Barge Basin, fitting BB-C3, Sta. 1+13, 24" cleat in good condition, #1 rating

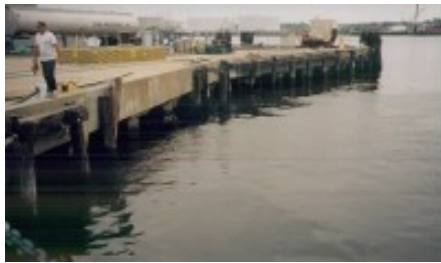
The fender system exhibits moderate deterioration over its entire length requiring repairs on a priority basis.

Photo 3.8-10 Berth 18, fender system with moderate deterioration looking east

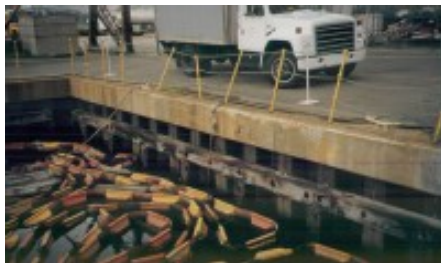
The fender system on the north face of Berth 20 exhibits moderate deterioration requiring repairs on a priority basis. On the south side of Berth 20 (Barge Basin), the fender system is in good operational condition.

Photo 3.8-12 Berth 20, fender system with moderate deterioration looking east

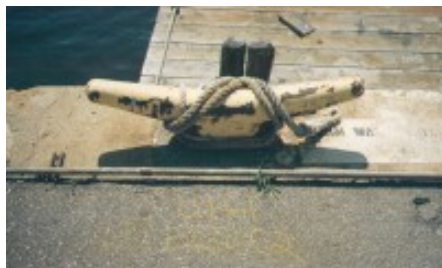
Photo 3.9-1 Berth 22, fitting B22-C2, Sta. 0+61 20 ton, 42" type 2 cleat in good condition, #2 rating

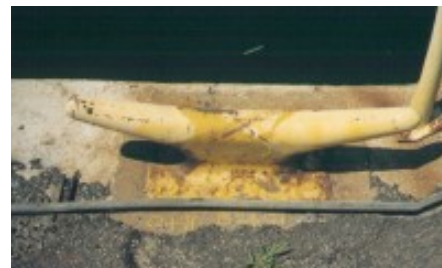
Photo 3.9-2 Berth 23, fitting B23-C1, Sta. 0+11 20 ton, 42" type 2 cleat in good condition, #2 rating

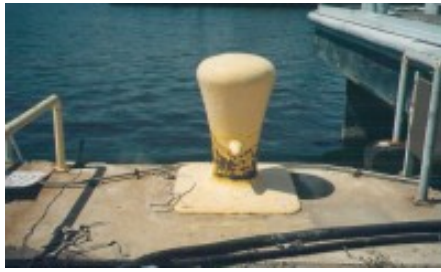
Photo 3.9-3 Berth 23, fitting B23-B1, Sta. 0+26 bollard in good condition, #1 rating

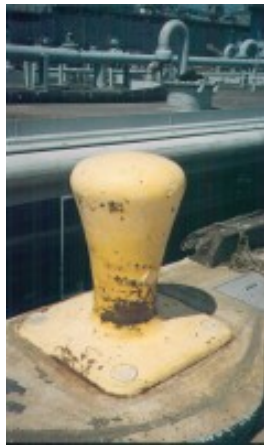
Photo 3.9-5 Berth 23, fitting B23-B2, Sta. 1+27, bollard in good condition, #2 rating

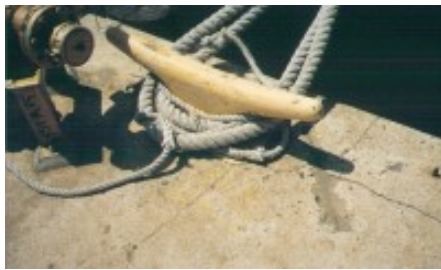
Photo 3.9-7 Berth 23, fitting B23-C7, Sta. 3+06 42" type 2 cleat in good condition, #2 rating

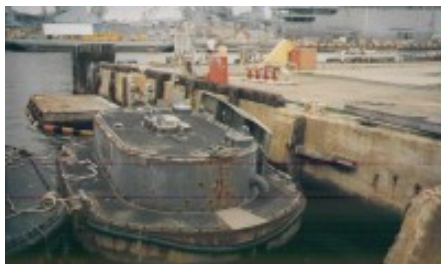
The fender system exhibits moderate deterioration requiring repair on a priority basis over its entire length. At Sta. 0+00 to Sta. 1+50, and at Sta. 3+50 to Sta. 5+00 the fender system exhibits severe deterioration and is non-functional.

Photo 3.9-9 Berth 22, fender system with moderate deterioration looking southwest

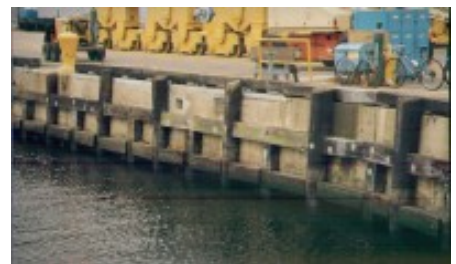
Photo 3.9-10 Berth 24, fender system with moderate deterioration looking northwest

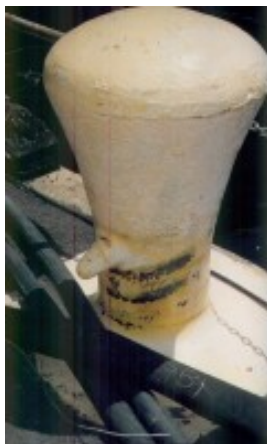
Photo 3.10-1 Berth 25, fitting B25-B1, Sta. 0+88, bollard in good condition, #2 rating

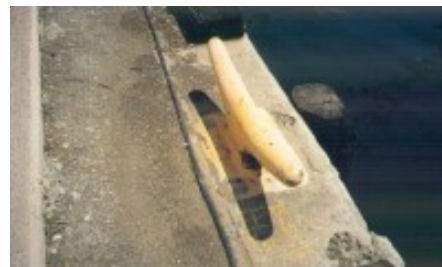
Photo 3.10-2 Berth 25, fitting B25-C4 Sta. 1+63, 42" type 2 cleat in good condition, #1 rating

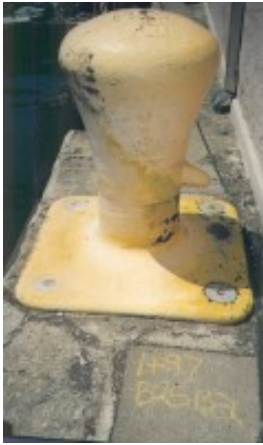
Photo 3.10-3 Berth 25, fitting B25-B2, Sta. 1+97, bollard in good condition, #2 rating

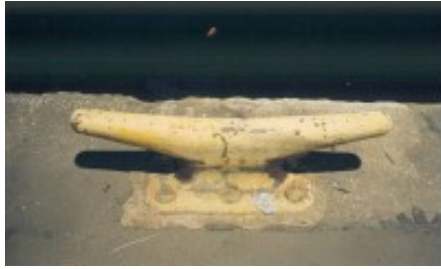
Photo 3.11-1 Berth 26, fitting B26-C1, Sta. 0+20, 42"
type 2 cleat in good condition, #1 rating

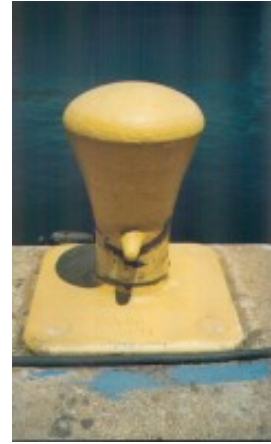
Photo 3.11-2 Berth 26, fitting B26-B1, Sta. 0+84, bollard
in good condition, #2 rating due to minor cracking of the
concrete base

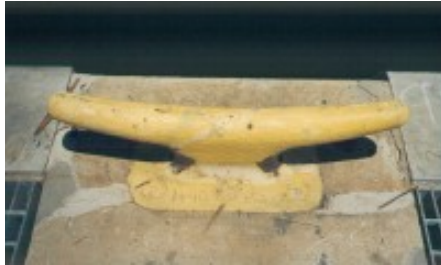
Photo 3.11-3 Berth 26, fitting B26-C3, Sta. 1+40, 42"
type 2 cleat in good condition, #1 rating

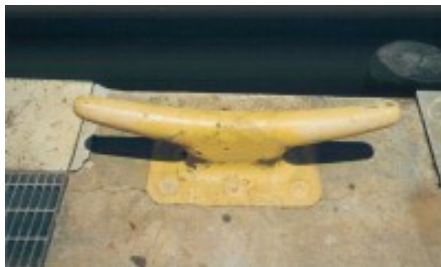
Photo 3.11-5 Berth 26, fitting B26-C9, Sta. 4+30, 42"
type 2 cleat in good condition, #2 rating

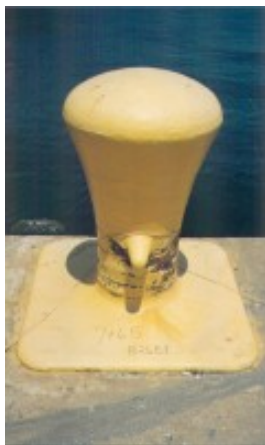
Photo 3.11-7 Berth 27, fitting B26-B8, Sta. 7+65, bollard in good condition, #2 rating due to abrasion damage on the barrel

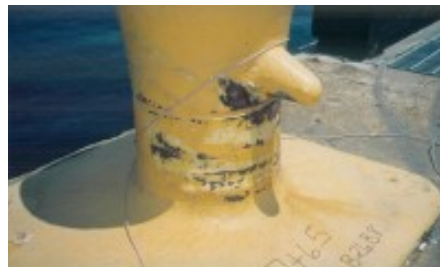
Photo 3.11-8 Berth 27, fitting B26-B8, Sta. 7+65, bollard, close-up view of abrasion damage

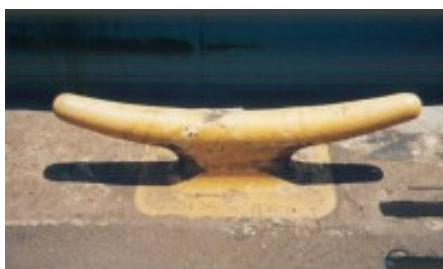
Photo 3.11-9 Berth 28, fitting B28-C1, Sta. 0+25, 42" type 2 cleat in good condition, #2 rating

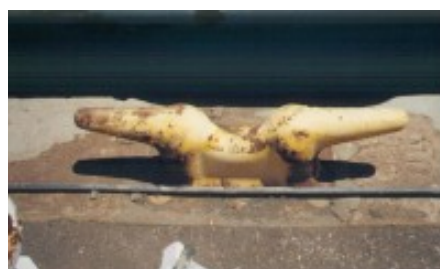
Photo 3.11-10 Berth 28, fitting B28-C2, Sta. 0+65, 42" type 1 cleat in good condition, #2 rating

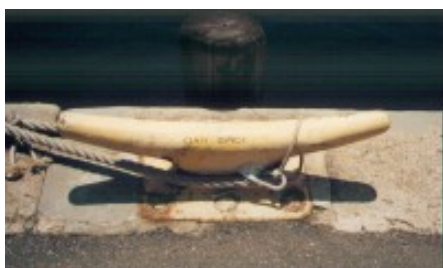
Photo 3.11-11 Berth 29, fitting B29-C1, Sta. 0+17, 42" type 2 cleat in good condition, #2 rating

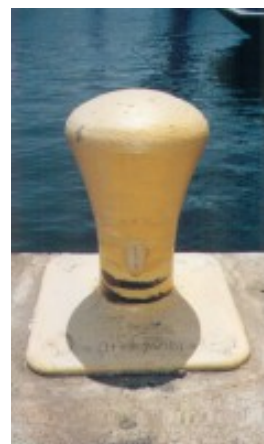
Photo 3.11-12 Berth 29, fitting B29-B1, Sta. 0+33, bollard in good condition, #2 rating

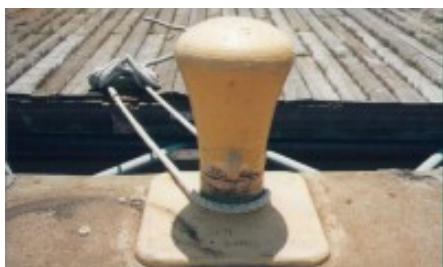
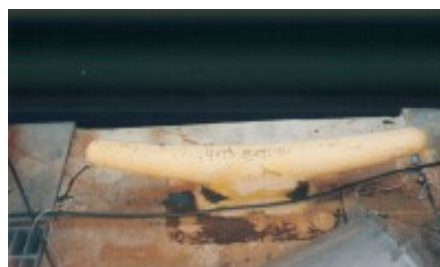
Photo 3.11-13 Berth 29, fitting B29-B3, Sta. 2+39, bollard in good condition, #2 rating

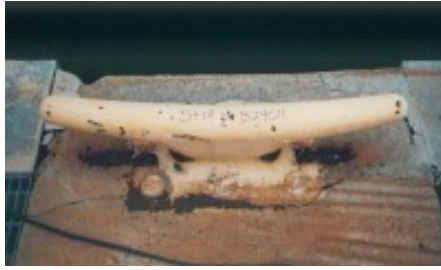
Photo 3.11-14 Berth 29, fitting B29-C10, Sta. 4+73, 42" type 2 cleat in good condition, #2 rating

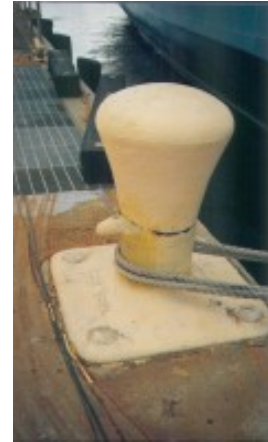
Photo 3.11-15 Berth 30, fitting B29-C11, Sta. 5+13, 42" type 2 cleat in good condition, #2 rating

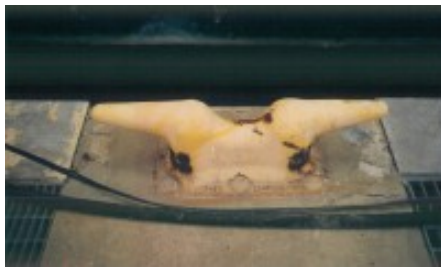
Photo 3.11-16 Berth 30, fitting B29-B6, Sta. 5+38, bollard in good condition, #2 rating

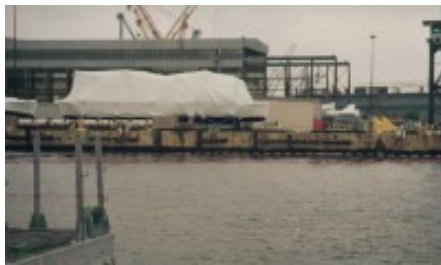
Photo 3.11-19 Berth 26, fender system with minor deterioration looking south

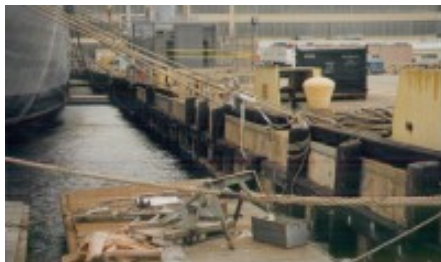
Photo 3.11-21 Berth 29, fender system with moderate deterioration looking northwest

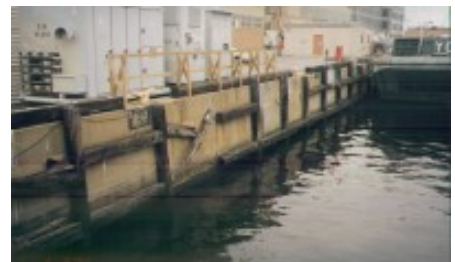
Photo3.11-22 Berth 30, fender system with moderate deterioration looking east

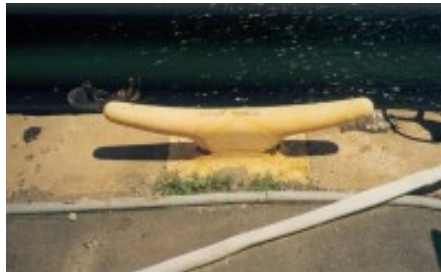
Photo 3.12-1 Berth 31, fitting B31-C2, Sta. 0+59, 42" type 2 cleat in good condition, #2 rating

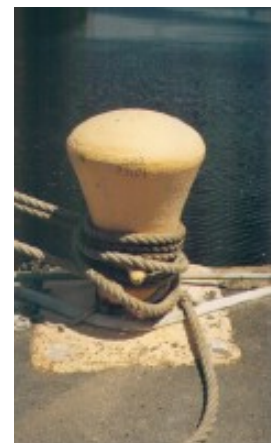
Photo 3.12-2 Berth 31, fitting B31-B1, Sta. 0+92, bollard in good condition, #2 rating

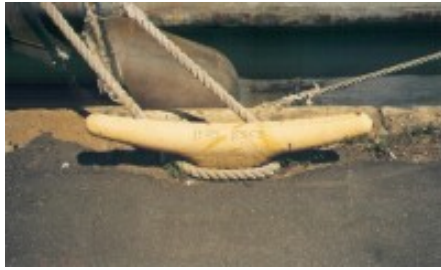
Photo 3.12-3 Berth 31, fitting 31-C3, Sta. 1+25, 42" type 2 cleat in good condition, #1 rating

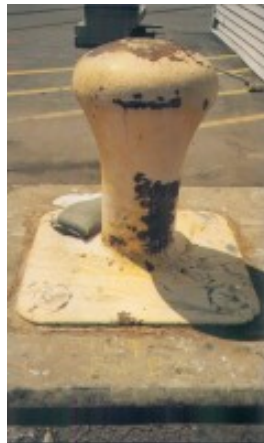
Photo 3.12-5 Berth 31, fitting B31-B2, Sta. 3+14, bollard in good condition, #2 rating

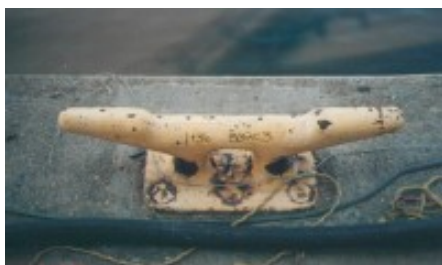
Photo 3.13-1 Berth 32, fitting B32-C3, Sta. 1+36, 42" type 3 cleat in good condition, #2 rating

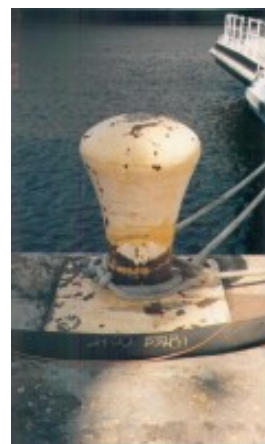
Photo 3.13-2 Berth 32, fitting 32-B1, Sta. 2+00, bollard in good condition, #2 rating

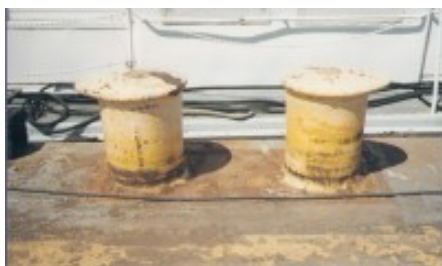
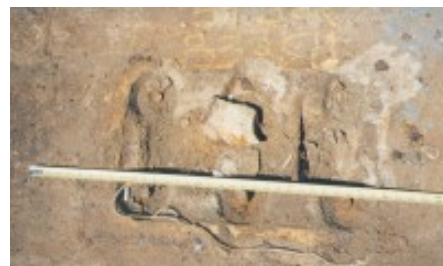
Photo 3.13-3 Berth 32, fitting B32-BT2, Sta. 2+96, high double bitt in good condition, #2 rating

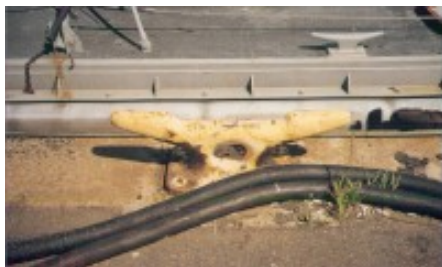
Photo3.13-11 Berth 34, fitting B34-C1 Sta. 0+36, 42"
type 3 cleat in good condition, #2 rating

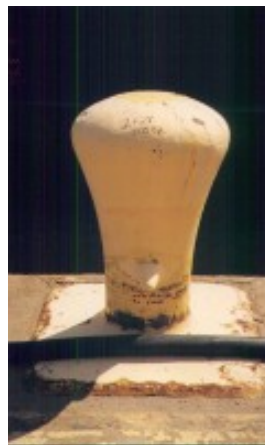
Photo 3.13-12 Berth 35, fitting B35-B2, Sta. 2+28,
bollard in good condition, #2 rating

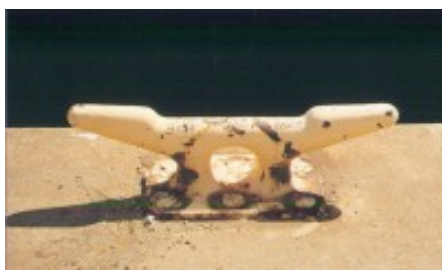
Photo 3.13-13 Berth 35, fitting B35-C8, Sta. 3+98, 42"
type 3 cleat in good condition, #2 rating

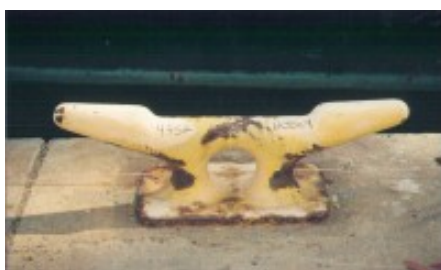
Photo3.13-14 Berth 35, fitting B35-C9, Sta. 4+52, 42"
type 3 cleat in good condition, #2 rating

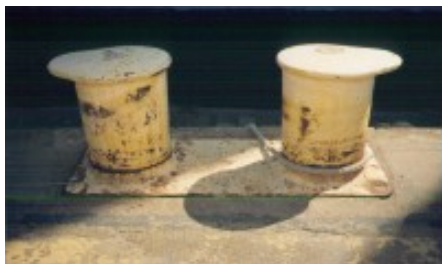
Photo 3.13-15 Berth 36, fitting B35-BT3, Sta. 5+13,
high double bitt in good condition, #2 rating

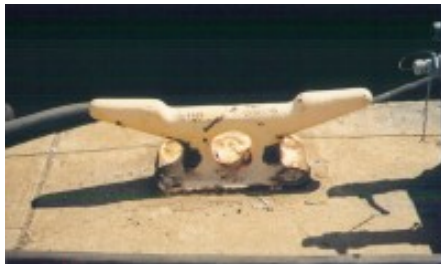
Photo3.13-16 Berth 36, fitting B35-C13, Sta. 6+44, 42"
type 3 cleat in good condition, #2 rating

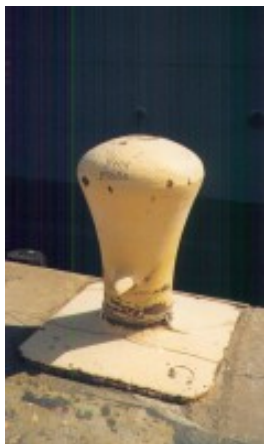
Photo3.13-17 Berth 36, fitting B35-B5, Sta. 8+04,
bollard in good condition, #2 rating

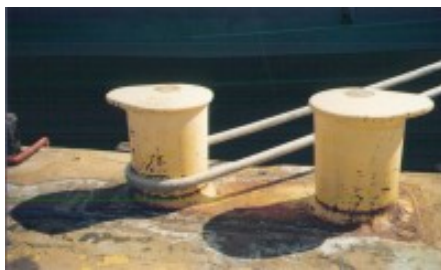
Photo 3.13-18 Berth 36, fitting B35-BT5. Sta. 9+00,
high double bitt in good condition, #2 rating

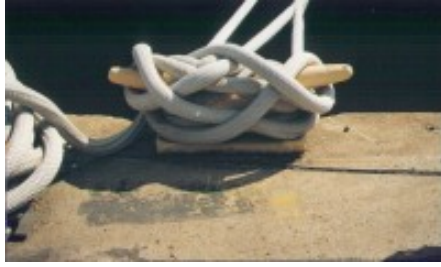
The existing conditions of each mooring fixture are noted in Data Table No. 13 and [FIG 3-13](#) in this section. The fixtures are rated based on a scale of 1 to 4 with 1 being excellent condition and 4 being poor condition. Both the fixture and its base are rated in this manner. One fitting, Cleat No. B35-C19 received a No. 4 rating due to spalled concrete on the concrete base. The spalling should be repaired as soon as possible; however, this condition does not affect the load rating of this cleat. All remaining fittings on Berth 35 and 36 have 1 or 2 ratings and are considered to be in good condition.

Photo 3.13-19 Berth 36, fitting B35-C19, Sta. 4+52, type 3 cleat in good condition, #3 rating

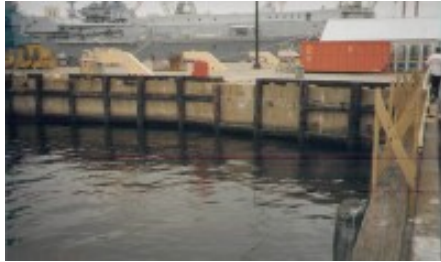
Photo3.13-21 Berth 32. fender system with minor deterioration looking south

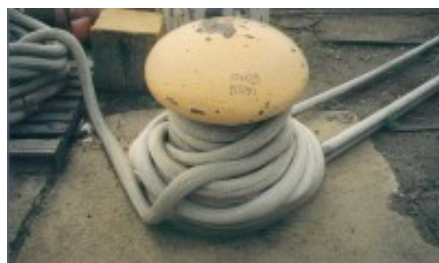
Photo 3.14-1, Berth 37, fitting B37-B1, Sta. 0+03, bitt in good condition, # 1 rating.

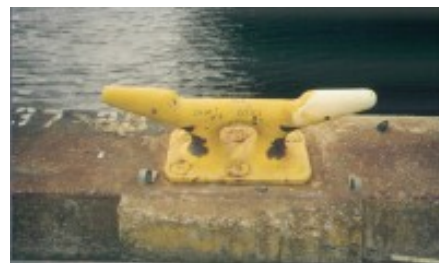
Photo 3.14-2, Berth 37, fitting B37-C1, Sta. 0+27, 42" type 3 cleat in good condition, #2 rating.

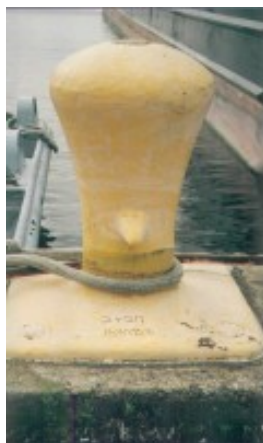
Photo 3.14-3, Berth 37, fitting B37-B3, Sta. 2+27, bollard in good condition, #2 rating.

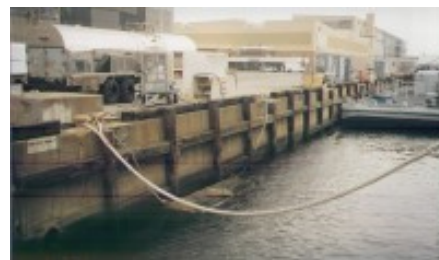
The existing conditions of each mooring fixture are noted in Data Table No. 14 and [FIG 3-14](#) in this section. The fixtures are rated based on a scale of 1 to 4 with 1 being excellent condition and 4 being poor condition. Both the fixture and its base are rated in this manner. All fittings on Berth 37 have 1 or 2 ratings and are considered to be in good condition. The timber fender system at Berth 37 is in good condition requiring minor repairs on a non-priority basis.

Photo 3.14-4, Berth 37, fender system with minor deterioration looking north.

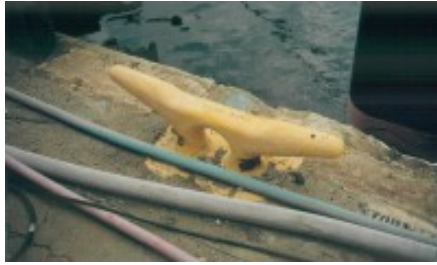
Photo 3.15-1, Berth 38, fitting B38-C1, Sta. 0+29, 42" type 3 cleat in good condition, #1 rating.

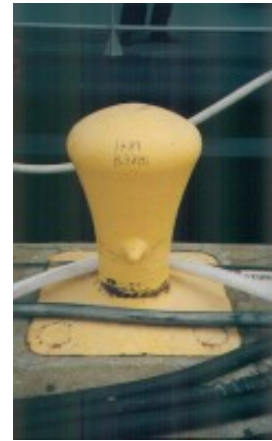
Photo 3.15-2, Berth 38, fitting B38-B1, Sta. 1+89, bollard in good condition, #2 rating.

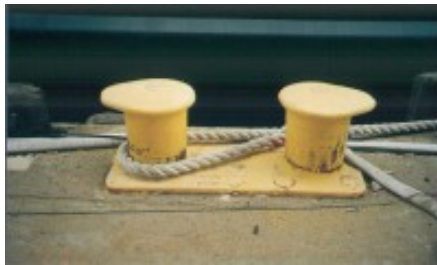
Photo 3.15-3, Berth 38, fitting B37-BT1, Sta. 0+93, low double bitt in good condition, #1 rating.

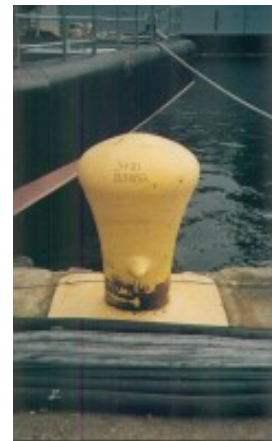
Photo 3.15-4, Berth 38, fitting B38-B2, Sta. 3+81, bollard in good condition, #2 rating.

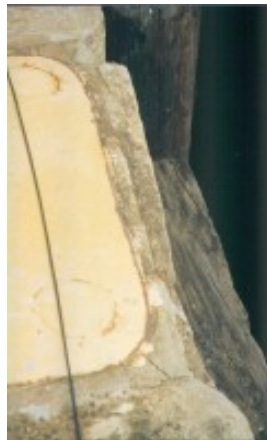
Photo 3.15-5, Berth 38, fitting B38-B2, Sta. 3+81, close-up view of damaged concrete edge.

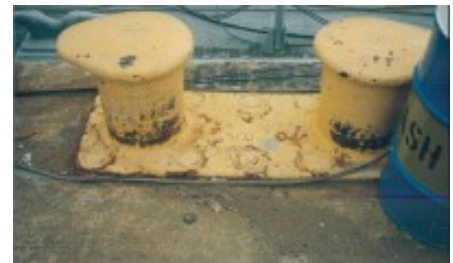
Photo 3.15-6, Berth 38, fitting B38-BT3, Sta. 4+77, low double bitt in good condition, #2 rating.

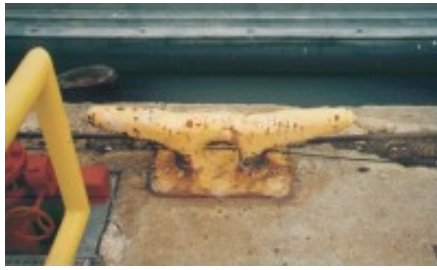
Photo 3.15-7, Berth 39, fitting B38-C14, Sta. 6+38, 42" cleat in good condition, #2 rating.

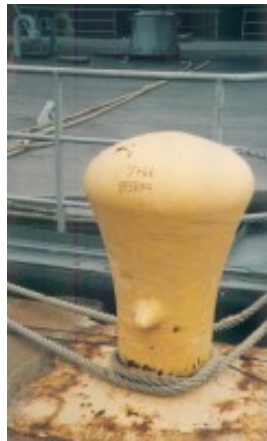
Photo 3.15-9, Berth 38, fitting B38-B4, Sta. 7+66, bollard in good condition, #2 rating.

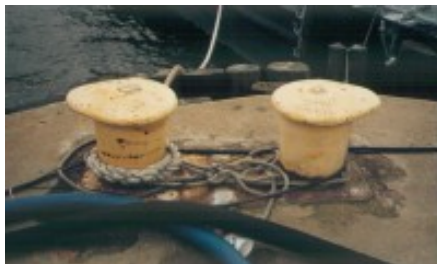
Photo 3.15-11, Berth 40, fitting B40-BT2, Sta. 0+41, low double bitt in good condition, #2 rating.

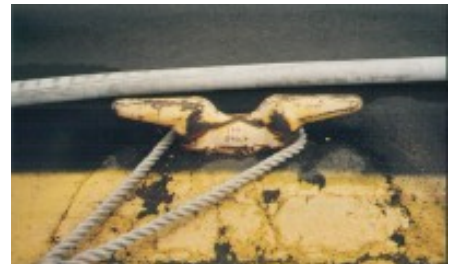
Photo 3.15-12, Berth 40, fitting B40-C2, Sta. 1+16, 42" type 1 cleat in good condition, #2 rating.

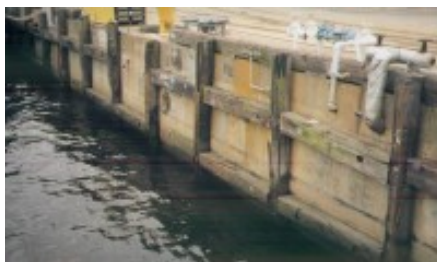
Photo 3.15-13, Berth 39, fender system with moderate deterioration looking east.

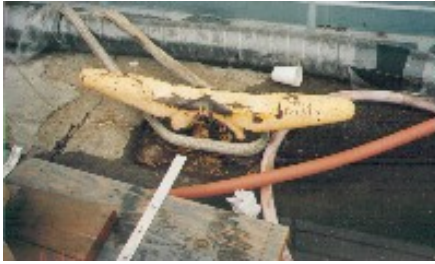
Photo 3.16-1, Berth 41, fitting B41-C1, Sta. 0+08, 42" type 3 cleat in good condition, #2 rating.

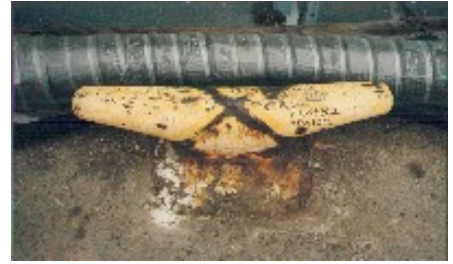
Photo 3.16-2, Berth 41, fitting B41-C2, Sta. 0+32, 30" cleat in good condition, #2 rating.

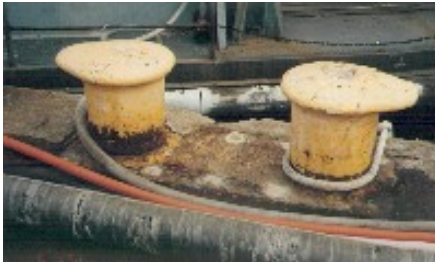
Photo 3.16-3, Berth 42, fitting B42-BT1, Sta. 0+17, low double bitt in good condition with scaling of the fitting base, #2 rating.

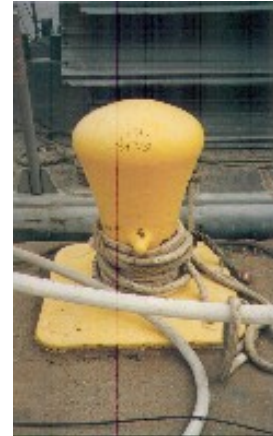
Photo 3.16-4, Berth 42, fitting B42-B1, Sta. 1+36, bollard in good condition, #1 rating.

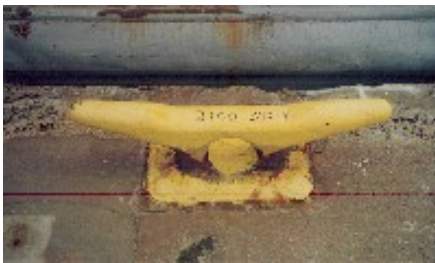
Photo 3.16-5, Berth 42, fitting B42-C4, Sta. 2+00, 42" type 3 cleat in good condition, #2 rating.

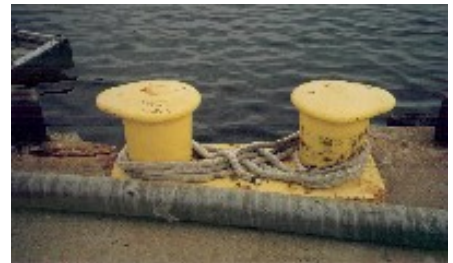
Photo 3.16-6, Berth 42, fitting B42-BT4, Sta. 4+25, low double bitt in good condition, #2 rating.

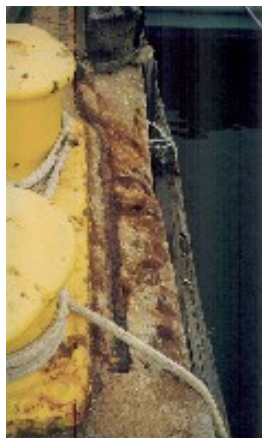
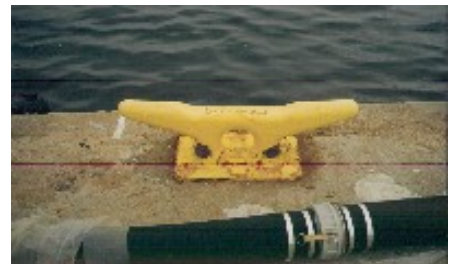
Photo 3.16-7, Berth 42, fitting B42-BT4, Sta. 4+25, low double bitt, close-up view of damaged concrete edge.

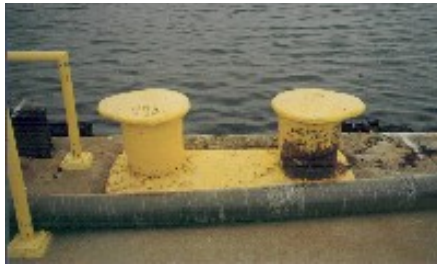
Photo 3.16-8, Berth 42, fitting B42-C11, Sta. 5+86, 42" type 3 cleat in good condition, #2 rating.

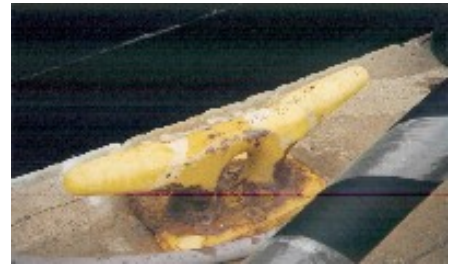
Photo 3.16-9, Berth 42, fitting B42-BT5, Sta. 6+19, low double bitt in good condition, #2 rating.

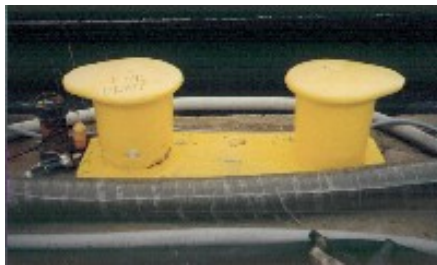
Photo 3.16-10, Berth 43, fitting B42-C20, Sta. 10+36, 42" type 3 cleat in good condition, #2 rating.

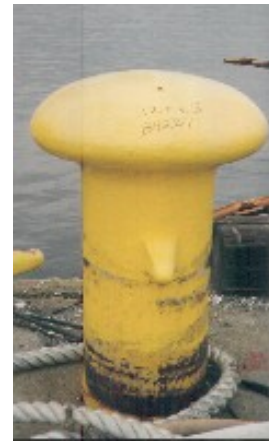
Photo 3.16-11, Berth 43, fitting B42-BT8, Sta. 11+96, low double bitt in good condition, #2 rating.

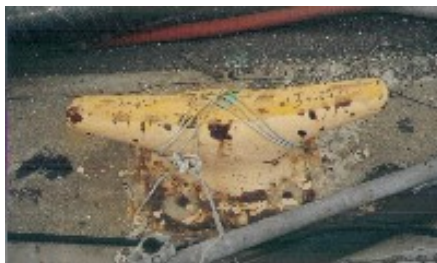
Photo 3.16-12, Berth 43, fitting B42-B7, Sta. 12+65, single bitt in good condition, #1 rating.

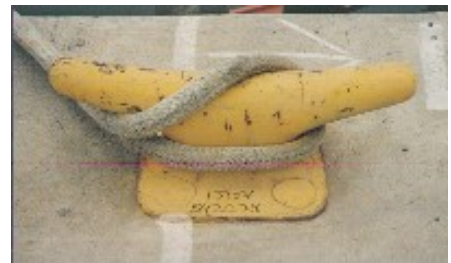
Photo 3.16-13, Berth 43, fitting B42-C27, Sta. 13+25, 30" cleat in good condition, #2 rating.

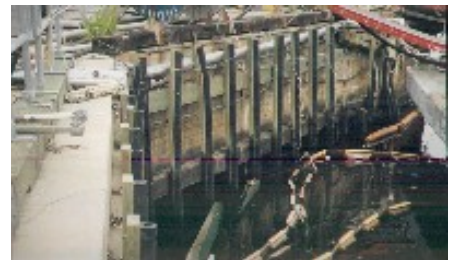
The timber pile fender system at Berth 41 is in good condition requiring minor repairs on a non-priority basis. The timber pile fender system on Berths 42 and 43 is in extremely poor condition requiring extensive repairs and/or replacement on a priority basis. Use of this fender system should be restricted until repairs are undertaken.

Photo 3.16-15, Berth 42, fender system with severe deterioration looking east.

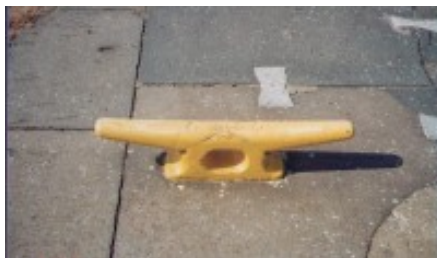
Photo 3.17-1, Dry Dock 1, fitting DD1S-C1, 40" cleat in good condition, # 1 rating.

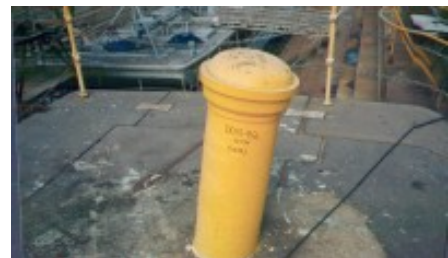
Photo 3.17-2, Dry Dock 1, fitting DD1S-B2, 12" dia pipe in good condition, # 1 rating.

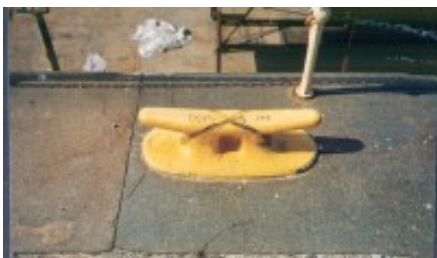
Photo 3.17-3, Dry Dock 1, fitting DD1S-C4, 26" cleat in good condition, # 2 rating due to minor cracking of granite base.

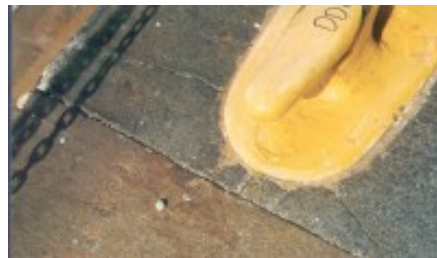
Photo 3.17-4, Dry Dock 1, fitting DD1S-C4, 26" cleat close-up view of cracking at base.

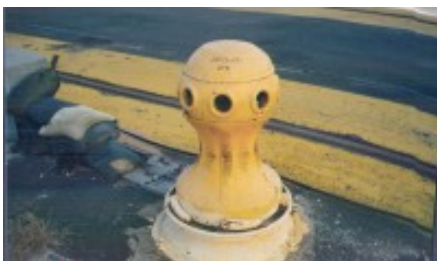
Photo 3.17-5, Dry Dock 1, fitting DD1S-CP1, windlass in good condition with # 2 rating.

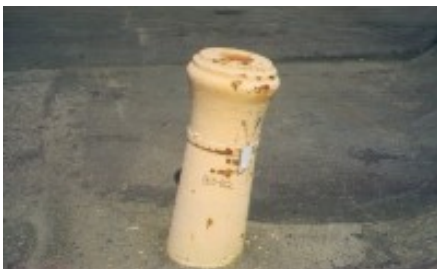
Photo 3.17-7, Dry Dock 1, fitting B13-B2, cannon barrel in good condition.

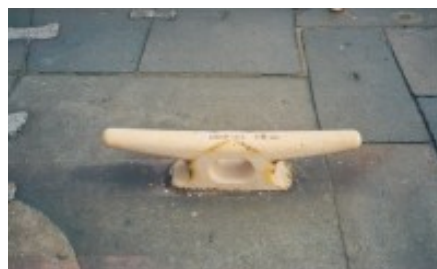
Photo 3.17-8, Dry Dock 1, fitting DD1P-C1, 40 "cleat in good condition, # 1 rating.

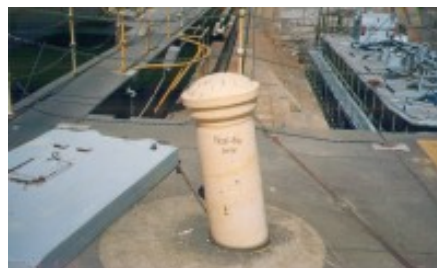
Photo 3.17-10, Dry Dock 1, fitting DD1P-B2, pipe in good condition, # 1 rating.

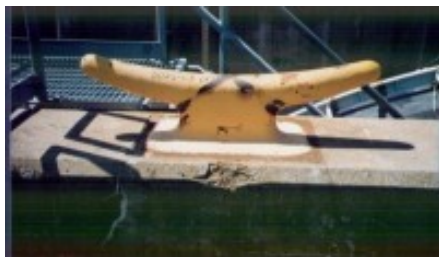
Photo 3.18-1, Dry Dock 2, fitting DD2S-C3, 42" type 2 cleat in good condition, #1 rating.

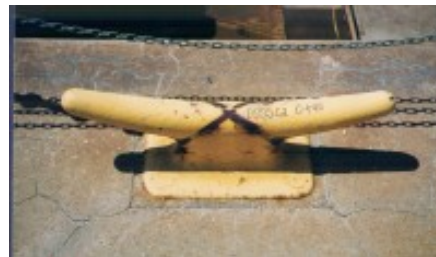
Photo 3.18-2, Dry Dock 2, fitting DD2S-C2, 42" type 2 cleat in good condition, #1 rating.

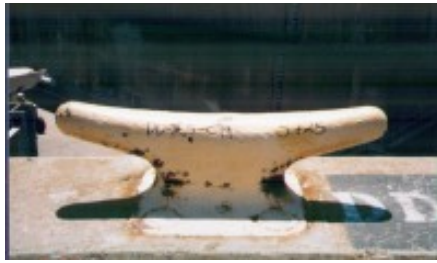
Photo 3.18-3, Dry Dock 2, fitting DD2S-C19, 30" cleat in good condition, # 1 rating.

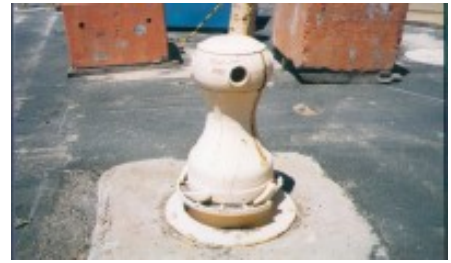
Photo 3.18-4, Dry Dock 2, fitting DD2S-CP4, windlass in good condition, # 1 rating.

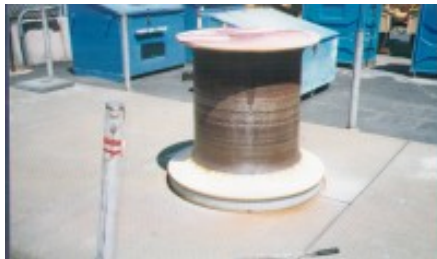
Photo 3.18-5, Dry Dock 2, fitting DD2S-CP2, capstan in good condition, # 1 rating.

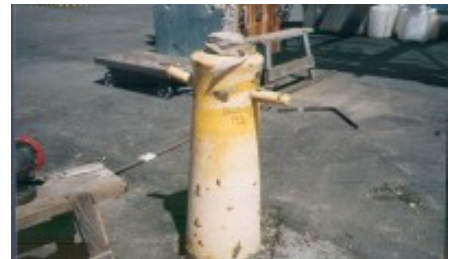
Photo 3.18-6, Dry Dock 2, fitting DD2S-B1, cannon barrel showing displacement, # 4 rating.

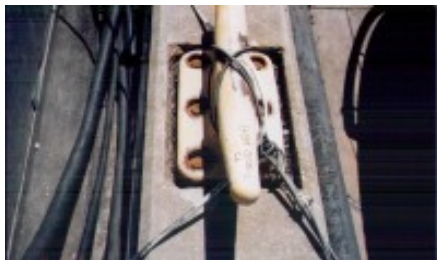
Photo 3.18-7, Dry Dock 2, fitting DD2S-C6, 42" type 2 cleat with ungrouted base and bolt pockets unfilled, # 3 rating due to evidence of corrosion on bolts.

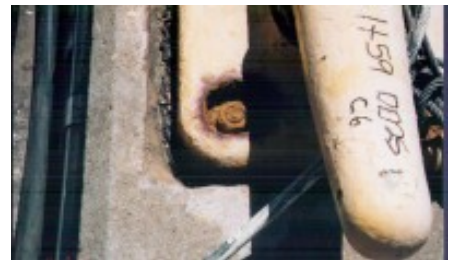
Photo 3.18-8, Dry Dock 2, fitting DD2S-C6, close up of cleat showing bolt pocket and base.

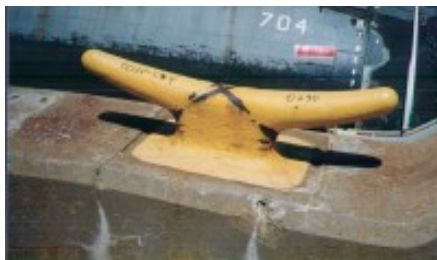
Photo 3.18-9, Dry Dock 2, fitting DD2P-C4, 42" type 2 cleat in good condition, # 1 rating.

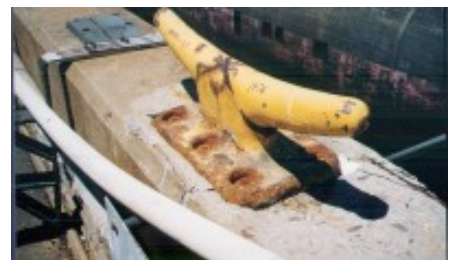
Photo 3.18-10, Dry Dock 2, fitting DD2P-C7, 42" type 2 cleat exhibits corrosion of base and bolts, # 4 rating.

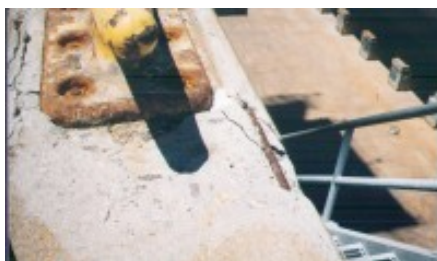
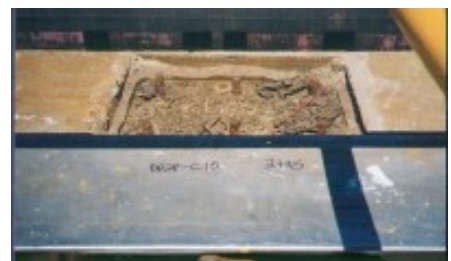
Photo 3.18-11, Dry Dock 2, fitting DD2P-C7, 42" type 2 cleat exhibiting cracking of the concrete base.

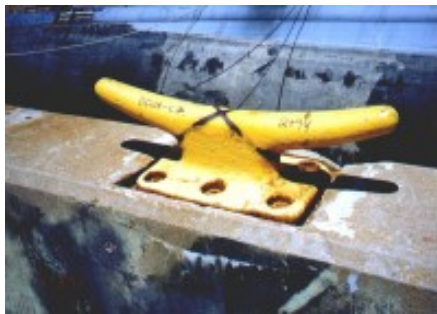
Photo 3.18-16, Dry Dock 2, fitting DD2S-C10, Sta. 2+64, 42" Type 2 cleat, ungrouted base and bolt pockets not filled, #3 rating.

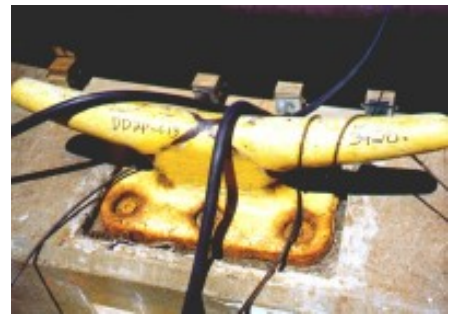
Photo 3.18-17, Dry Dock 2, fitting DD2S-C11, Sta. 2+91, 42" Type 2 cleat, ungrouted base and bolt pockets not filled, #3 rating.

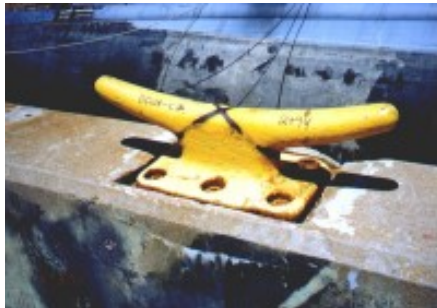
Photo 3.18-18, Dry Dock 2, fitting DD2P-C13, Sta. 3+20, 42" Type 2 cleat, ungrouted base and bolts pockets not filled, #3 rating.

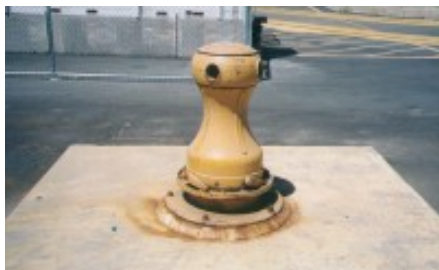
Photo 3.19-1, Dry Dock 3, fitting DD3S-CP5, windlass in good condition, #2 rating.

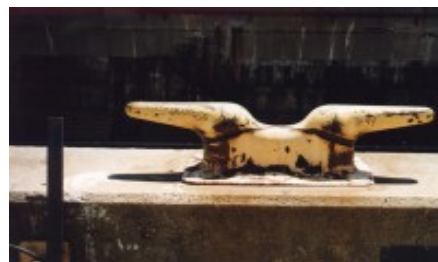
Photo 3.19-2, Dry Dock 3, fitting DD3S-C5, 42" type 1 cleat in good condition, #1 rating.

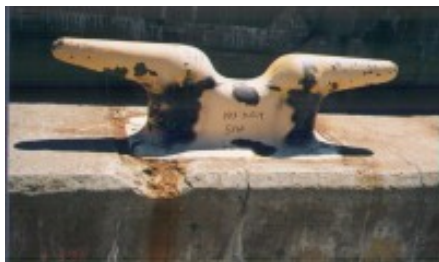
Photo 3.19-3, Dry Dock 3, fitting DD3S-C14, 42" type 1 cleat in good condition, # 1 rating.

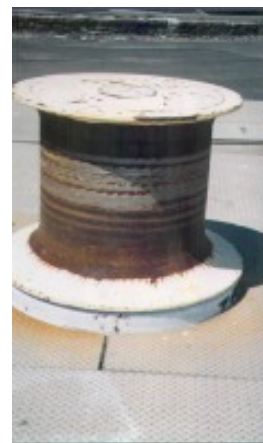
Photo 3.19-4, Dry Dock 3, fitting DD3S-CP7, capstan in good condition, # 1 rating.

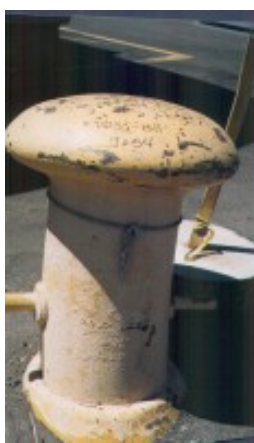
Photo 3.19-5, Dry Dock 3, fitting DD3S-B11, single bitt in good condition, #1 rating.

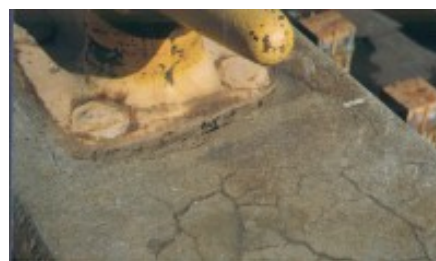
Photo 3.19-6, Dry Dock 3, fitting DD3P-C7, 42" type 1 cleat close up showing concrete base, minor map cracking is evident, #1 rating.

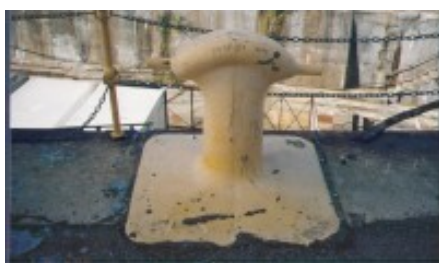
Photo 3.19-7, Dry Dock 3, fitting DD3P-B7, small bollard in good condition, #1 rating.

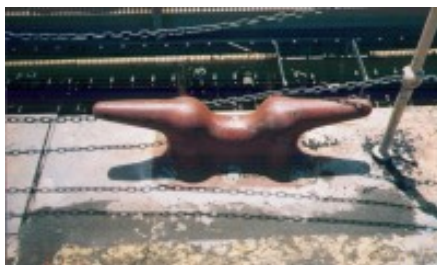
Photo 3.20-1, Dry Dock 4, fitting DD4S-C11, 42" type 1 cleat in good condition, # 1 rating.
